MARYLAND
GUILFORD RESERVOIR

NDI ID NO. MD-106

PHASE I INSPECTION REPORT
NATIONAL DAM INSPECTION PROGRAM

JUNE 1980

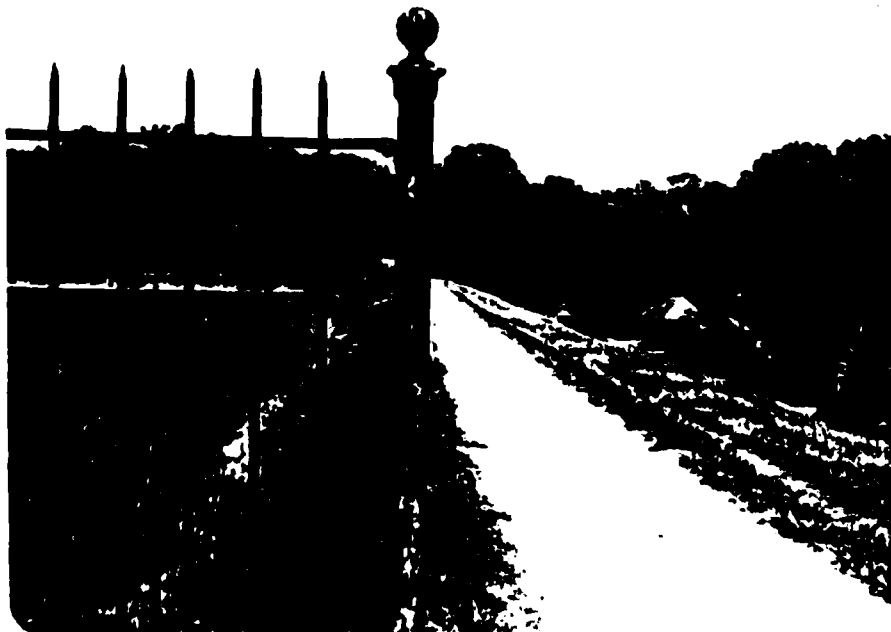
Southern Crest
